FILM REVIEW BOOK 3002 and 3003

POWER STEERING PUMP DIAGNOSIS and TESTING

VOL. 69 S2 L2A

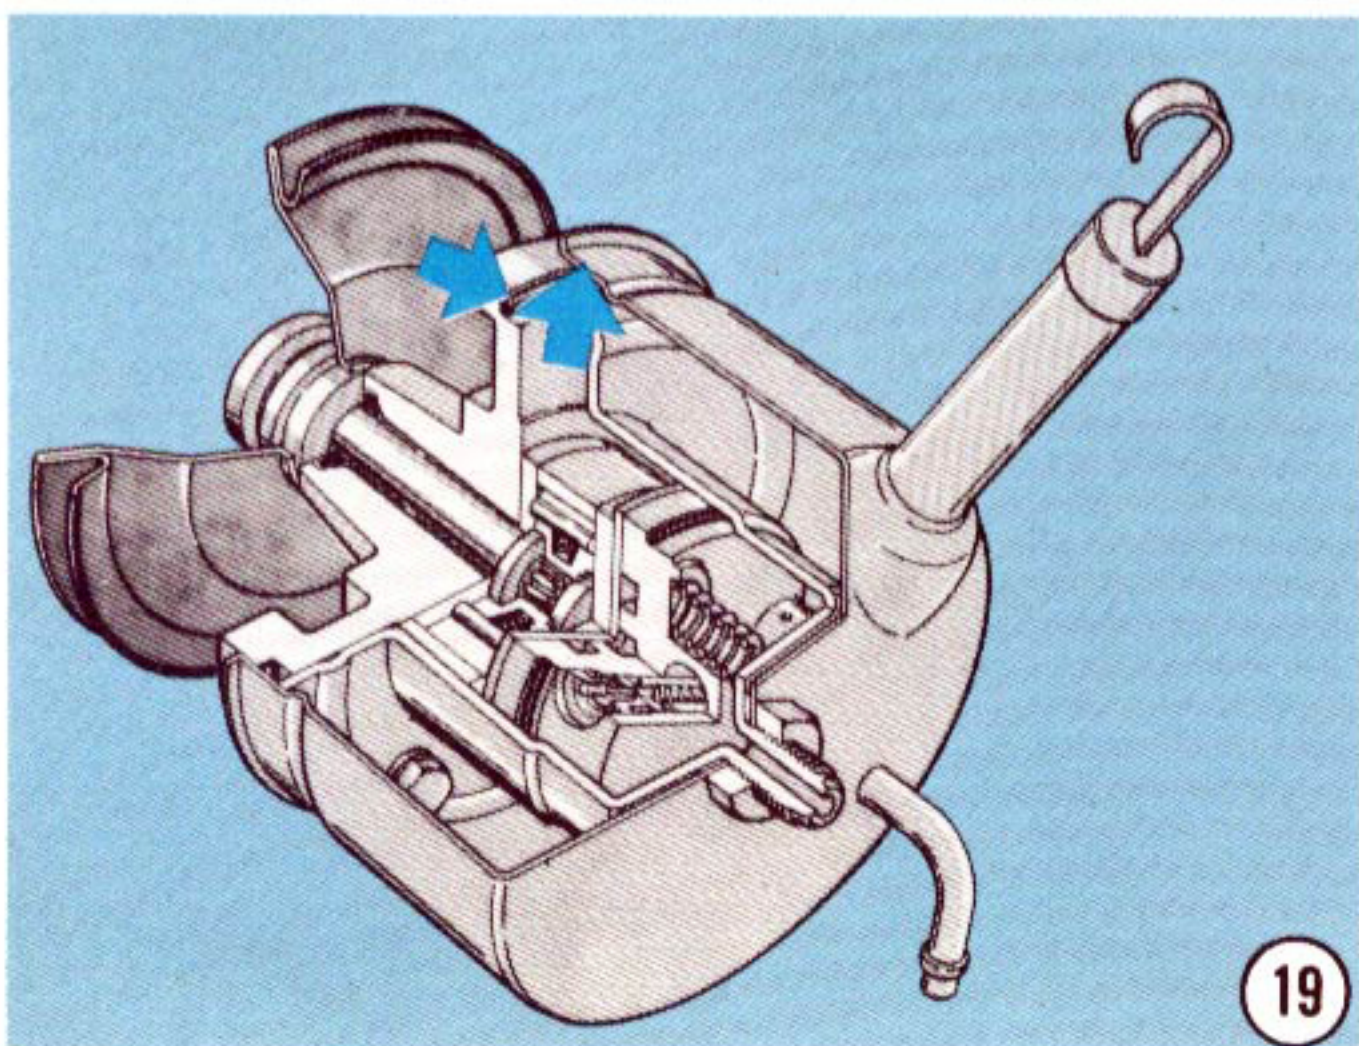
Damaged Reservoir or Housing Plate

Another reason for leakage at the reservoir O-ring seal is a damaged inside diameter of the reservoir or a damaged outside diameter of the housing plate. There must be no damage to these mating surfaces. If there is, the damaged part must be replaced.

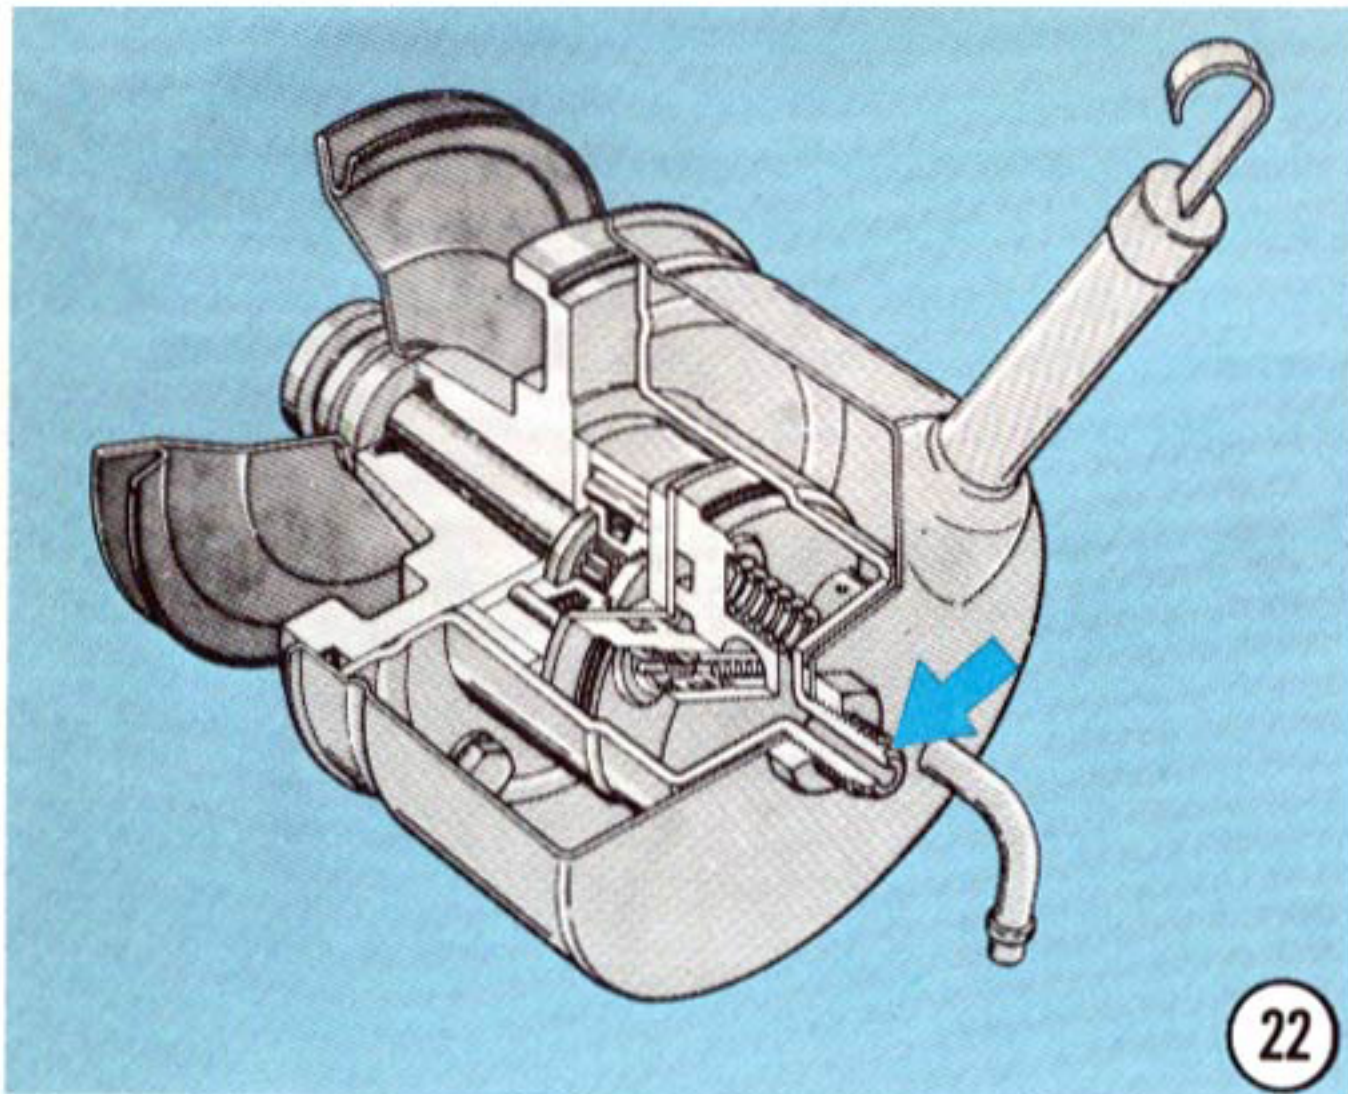
External Leakage at Outlet Fitting

External leakage may be observed at the area of the outlet fitting. Close inspection may indicate that the fitting is improperly assembled.

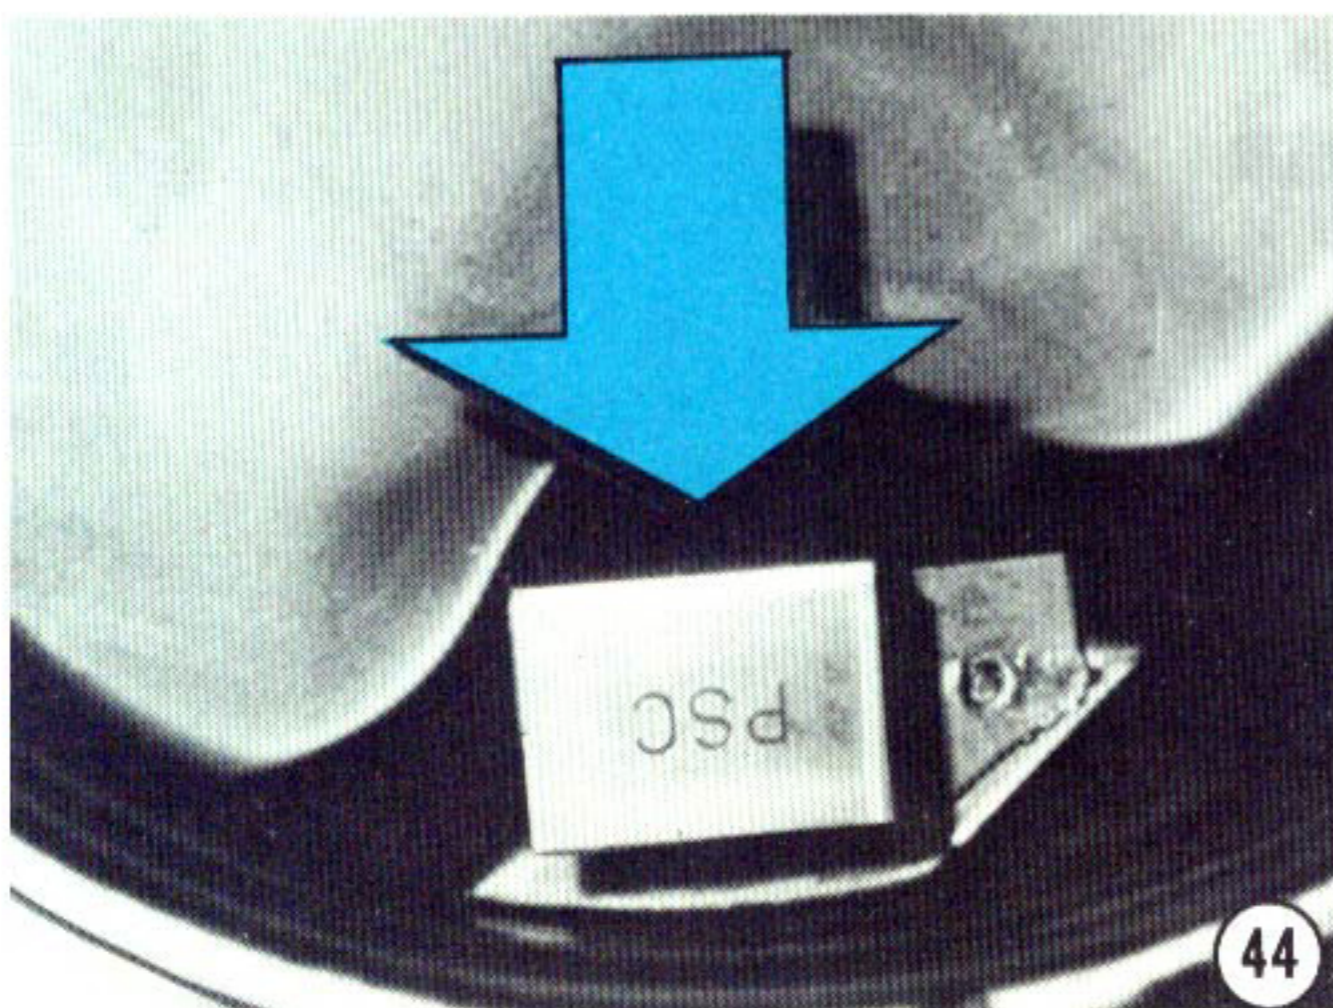
Broken Reservoir Baffle

A broken reservoir baffle will result in aerated fluid.

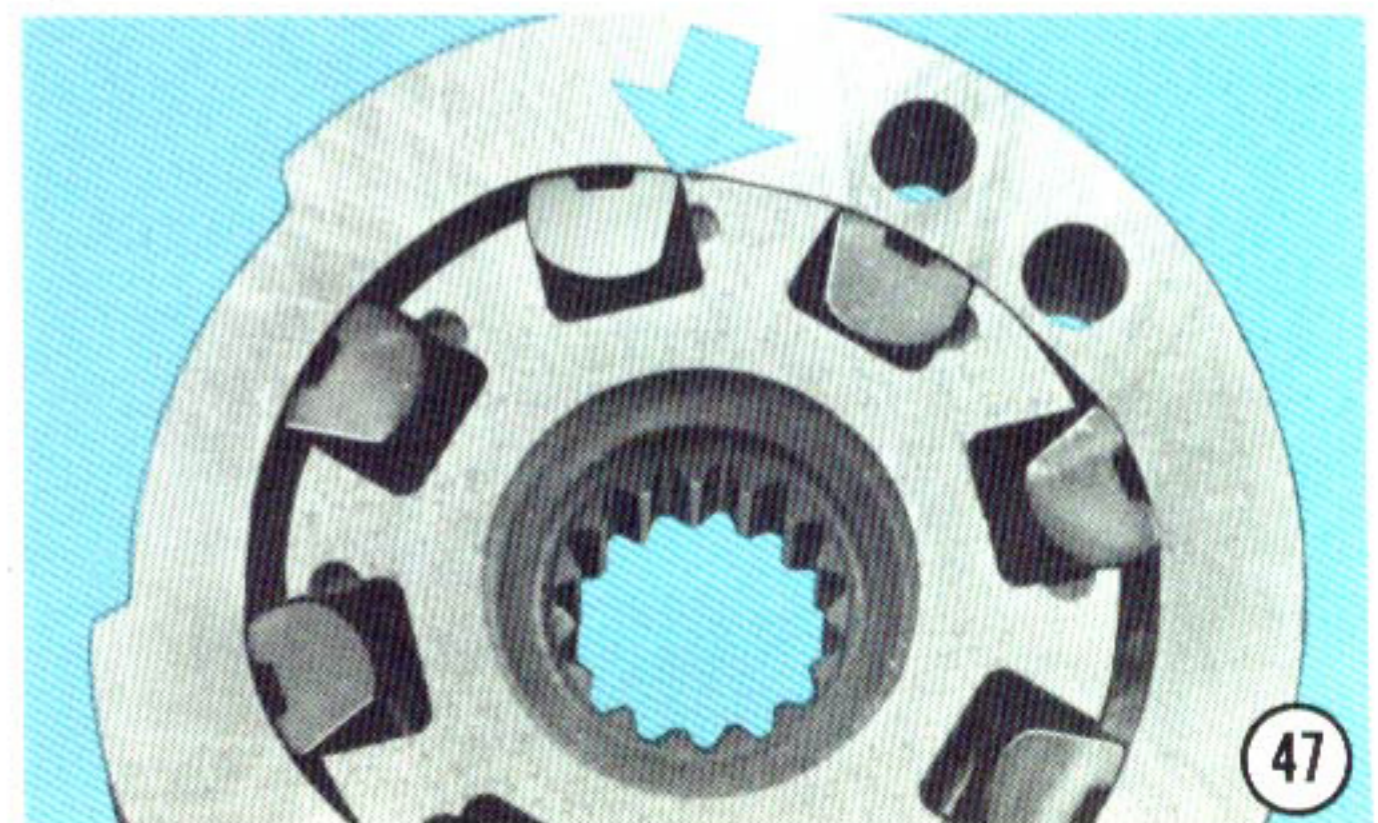
- Improper assembly of components such as slippers. For example, the slipper illustrated has been installed backward and the flat is facing in the wrong direction.

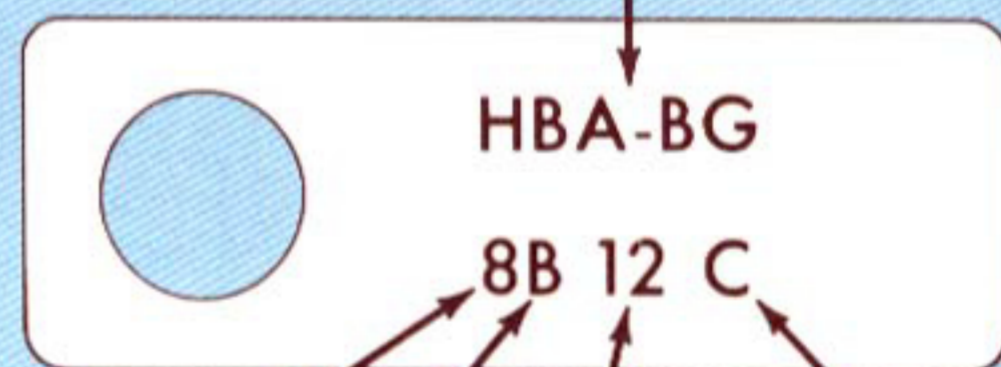
SERVICE MODEL IDENTIFICATION

YEAR, MONTH, DAY
DATE CODE

SHIFT CODE
